NCKRI REPORT OF INVESTIGATION 13

**ELECTRICAL RESISTIVITY SURVEY OF A PSEUDOKARST  
SINKHOLE HAZARD, VILLAGE OF SAN MATEO,  
CIBOLA COUNTY, NEW MEXICO**

Lewis Land, George Veni  
National Cave and Karst Research Institute

October 2021

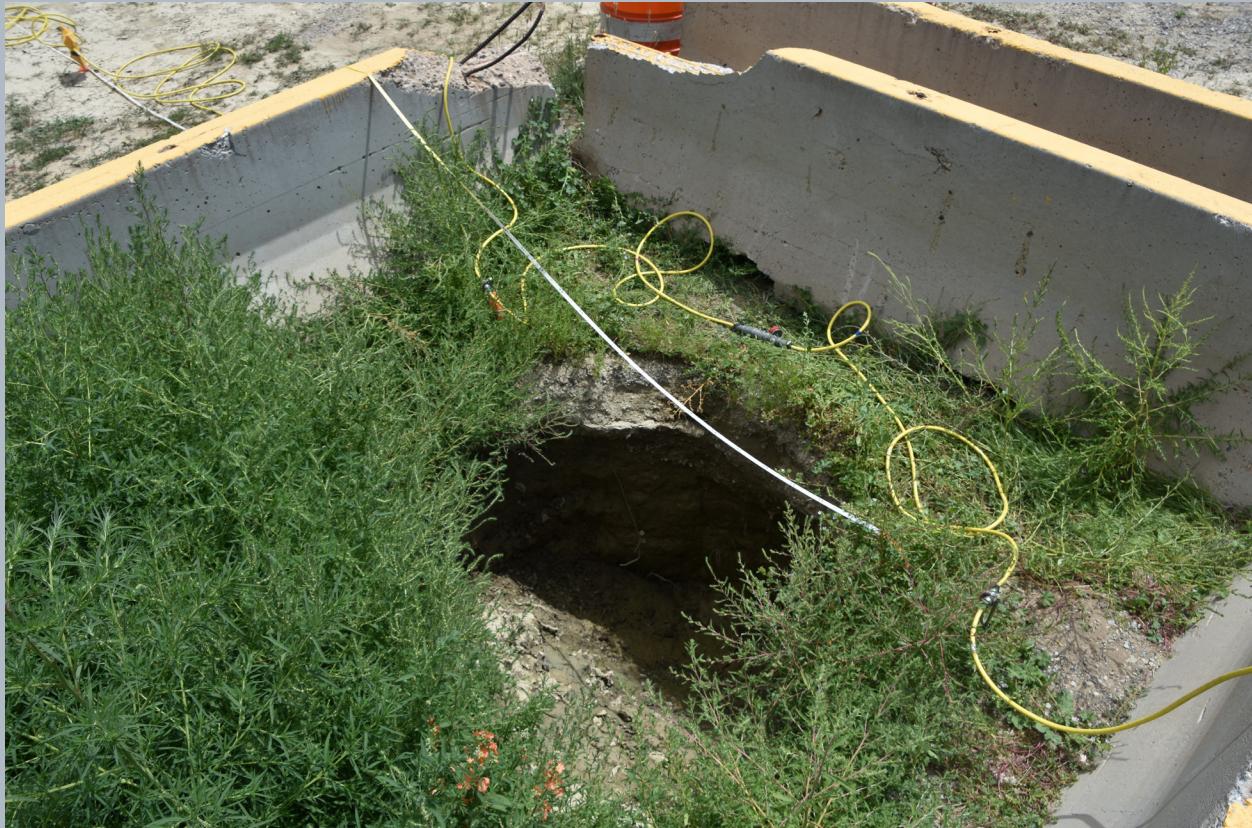
**Cover photo:** Sinkhole during the electrical resistivity survey. A white measuring tape extends over the sinkhole and electrodes are connected into the yellow cable on each side of the sinkhole. NCKRI staff photo by George Veni.

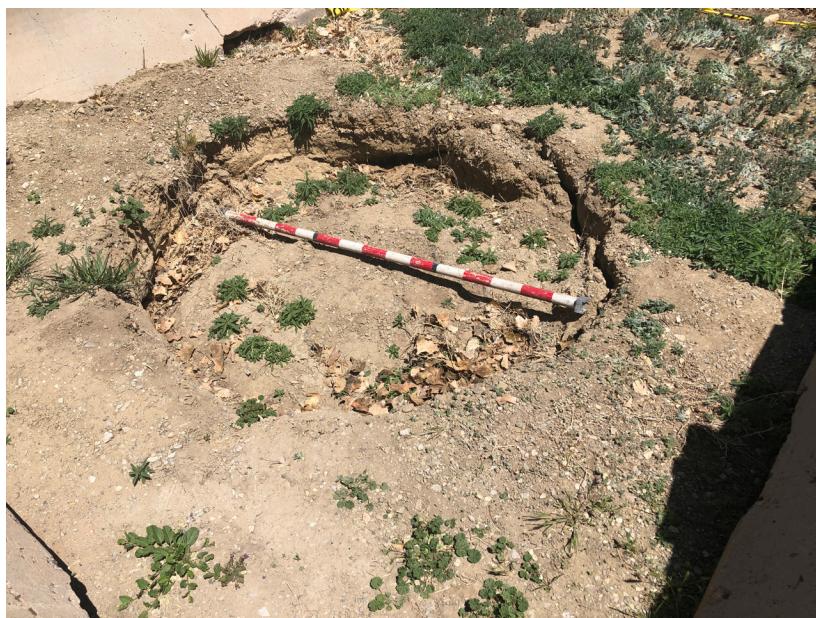
**Figure 1.** San Mateo sinkhole, located on the north shoulder of CR 605. NCKRI staff photo by Lewis Land.

In mid-April 2021, Cibola County management personnel reported the occurrence of what appeared to be a small sinkhole ~1.5 m in diameter and 1 m deep, located on the north shoulder of County Road 605 in the village of San Mateo, New Mexico (Figures 1 and 2). The sinkhole was filled quickly with compacted soil to a mound several centimeters above grade. A site inspection on 29 June 2021 found that over the past two months the soil mound had subsided and the space was now occupied by a depression roughly 10 cm below ground level (Figure 1). Features such as this often form in urban settings when aging utility lines in the shallow subsurface collapse. However, a careful examination of the records by Cibola County personnel indicates that the main water line for the village is located 17 m to the south on the other side of CR 605. There are no records of utility lines underlying the sinkhole itself (Figure 2), thus the feature appears to be naturally caused and not of human origin.

The sinkhole is formed in soil and alluvial material ~8 to 25 m thick overlying upper Cretaceous bedrock of the Menefee Formation (Dan Koning, 2021, personal communication). Lithology of the Menefee Formation consists of non-marine sandstone, shale and coal beds, and is generally not consistent with the formation of typical karst features such as sinkholes. There is a history of coal and uranium mining in the area, but consultation with local mine operators did not reveal any mine activity beneath the village of San Mateo itself. This feature may be the result of soil piping, wherein individual particles of soil can be eroded and transported by the subsurface flow of groundwater that is focused along preferential flow paths (Allison and Shipman, 2007). However, without a more detailed investigation this hypothesis could not be proven. After consultation with Cibola County managers, NCKRI personnel proposed conducting an electrical resistivity survey of the sinkhole to determine if there were any underlying cavities that could cause additional subsidence or catastrophic collapse.

Upon arrival at the sinkhole on 21 August 2021, we found it had widened to 1.5 by 1.7 m and deepened to 1.3 m over the past two months. We assumed that the sinkhole was underlain by a subsurface void or air-filled rubble, however the depth of the void was uncertain. We therefore conducted three ER surveys over and adjacent to the San Mateo sinkhole on the north shoulder of CR 605 (Figure 3). Lines SM2 and SM3 were deployed approximately one and two meters

While no cause for the sinkhole is apparent, and the cavity that resulted in the collapse may now be filled and thus does not appear in the ER imagery, prudence suggests continuing to investigate its origin. This can be accomplished during remediation. A backhoe should excavate the sinkhole down to undisturbed alluvium, soil, or bedrock. Based on the ER images, this will probably be found within about 5 m of the surface. A geologist should be present on site during the excavation to identify the undisturbed materials and determine what caused the collapse. The ER survey indicates such excavation can be conducted safely.

Most sinkholes form by groundwater transporting sediment to create a void. If this is confirmed by excavation and the base of the sinkhole is found, the excavated material should be replaced with a graded back-fill. The basal 25% of the excavation should be filled with large cobbles, the next 25% with coarse gravel, above that pea-size gravel, and then the top 25% with soil. This sequence of fill will allow natural and artificially induced groundwater to flow through the material without displacing it, preventing development of future voids and sinkholes in that location.

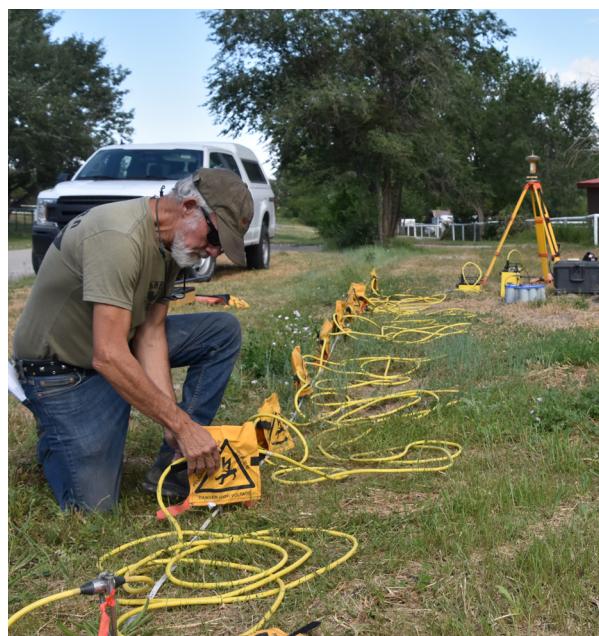
Dr. Land places protective covers over the electrodes to prevent accidental electrical shock if touched while active. NCKRI staff photo by George Veni.
